AC Microchron® II Vital Timer Relay

KB Signaling's AC Microchron® II Timer Relay is AREMA-compliant, using solid state technology to replace both 25 Hz and 60 Hz AC motor timers.

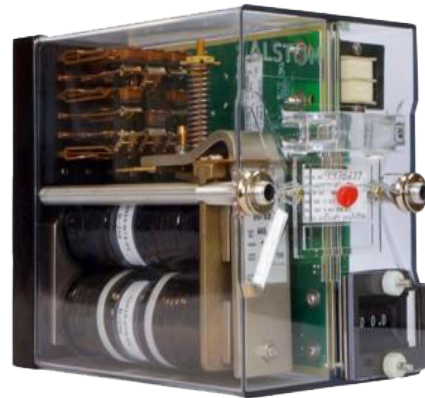
The AC Microchron® II Vital Timer Relay is a timing relay mechanism consisting of a timing package and a relay assembly housed within a B2 relay cover. The timer electronics are designed to delay the relay “picking” from the moment power is applied to, at least, the duration set on the thumbwheel switch. The AC Microchron II Vital Timer Relay is vitally designed to prevent time delay interval shorter than what has been set using the thumb wheel switches.

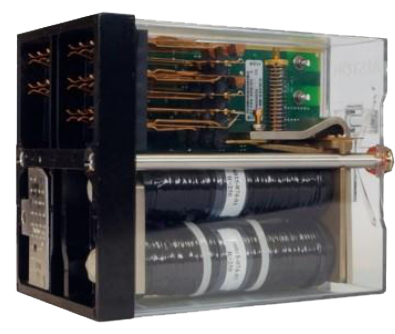
Relay Contact Arrangement

Front View
